Manhole Inspection Summary

Manhole # S29A__010MH

Location Address: **1003 MYRTLE AVE**

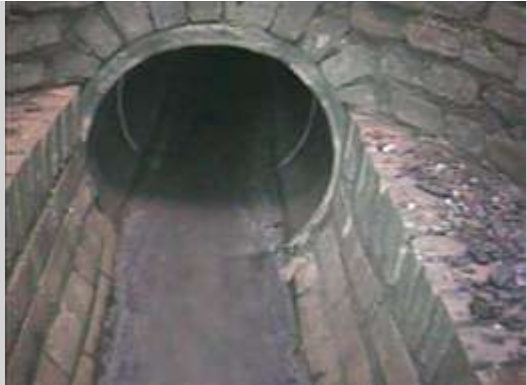
12 O'Clock Outflow

18 in. Circular Gravity Sewer
Pipe Out @ 12 O'Clock

Pipe Height: **14.4** (in.) Rod and Bar
Pipe Material: **Clay** ☐ Pipe Lined
Invert Depth: **10.74** (ft.) Flow Characteristics: **Fast**
Deposits: ☒ None ☐ Mud ☐ Sludge ☐ Debris ☐ Grease
Silt Depth: (in.) Deposits Extent:
Infiltration: **None** Pipe Seal Cond: **Sound**

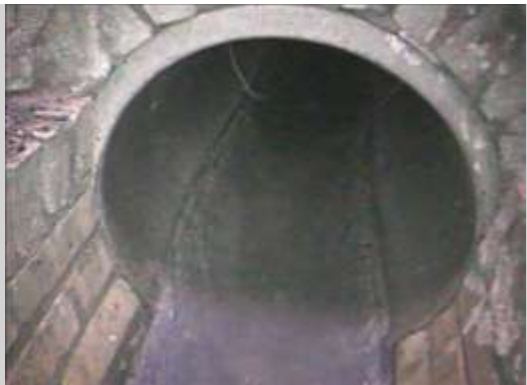
6 O'Clock Inflow

18 in. Circular Gravity Sewer
Pipe In @ 6 O'Clock

Pipe Height: **14.4** (in.) Rod and Bar
Pipe Material: **Clay** ☐ Pipe Lined
Invert Depth: **10.70** (ft.) Flow Characteristics: **Fast**
Deposits: ☒ None ☐ Mud ☐ Sludge ☐ Debris ☐ Grease
Silt Depth: (in.) Deposits Extent:
Infiltration: **None** Pipe Seal Cond: **Sound**
